Product Release Notes for 3ware 9750 SATA+SAS 6Gb/s RAID Controller Cards

Release 10.2.2.2

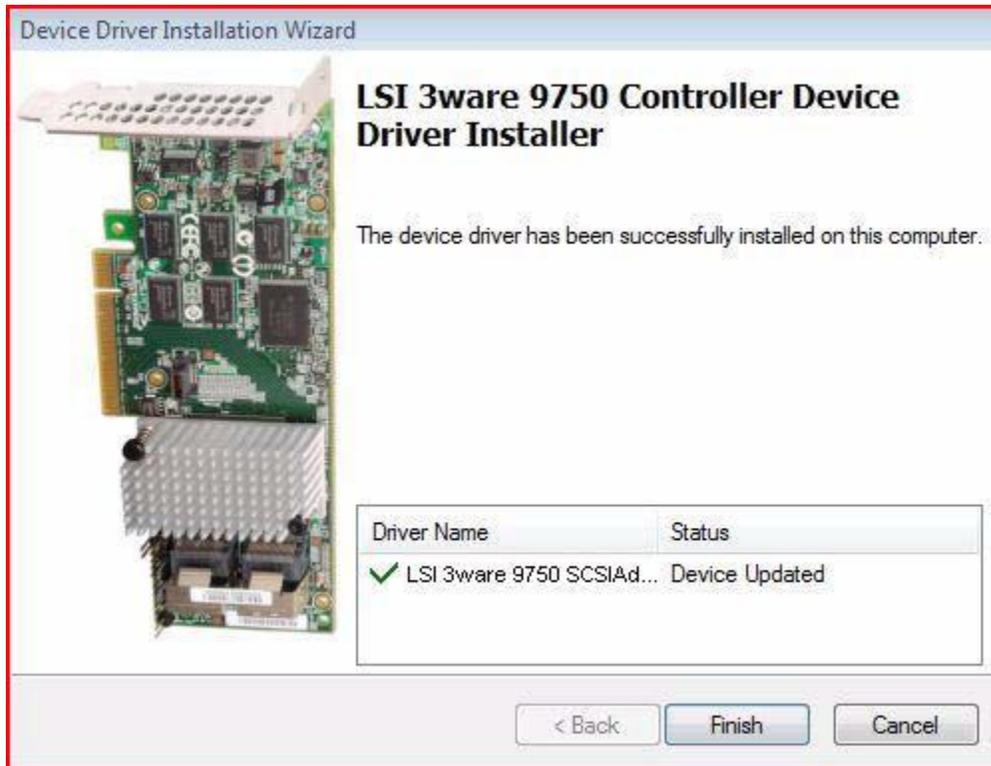
3ware Device Driver Final Installation Screen:

You will see the following screen. The green checkmarks indicate successful installation of the driver. If unsuccessful, there will be a red checkmark.
